Flint Public Library

Conditions Assessment

Building Conservation Associates, Inc. (BCA) was hired by the Town of Middleton to conduct a conditions assessment of the Flint Public Library. Two site visits were conducted in August and September 2024 to tour the buildings, take photographs and note the materials and conditions. Loretta Swift Johnson, Flint Public Library Director and Justin Sultzback, Middleton Town Administrator met with Lisa Howe on site in August. Documents related to the 2006 addition were reviewed, and Loretta gave a tour of the leaks, cracks and concerns observed around the building. BCA conducted a follow up visit in September to complete a more in depth review of the conditions.

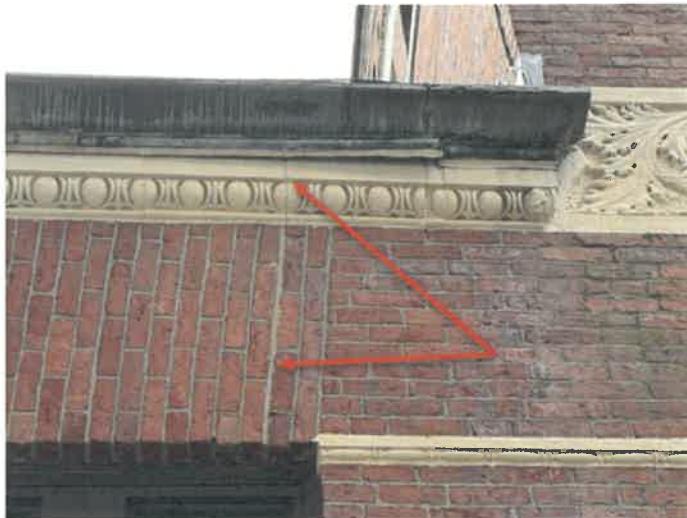
In general, the brick is in very good condition. Some of the mortar used to repoint selective areas is not the best color or texture match to the original mortar, but it all seems to be performing well. There are some step cracks that run through the brick and in some cases the sandstone on the east and north (Fig. 1) elevations. These cracks indicate past or ongoing movement, and they should be monitored to determine if they are still moving. The shifting opened the mortar joints around the step crack, allowing water infiltration at the open joints. Ongoing water infiltration will accelerate the deterioration of the

mortar and surrounding bricks. The movement and step cracks on the east elevation could be related to the excavation for the new addition in 2006.

Fig. 1. Step crack through brick joints and sandstone trim.

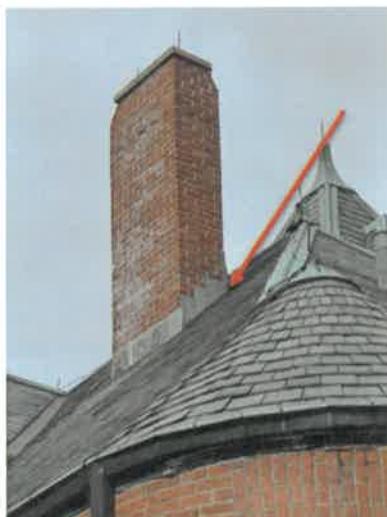
The flashing around the chimney on the southeast roof slope is in poor condition and could be resulting in the leaks observed on the attic stair wall and roof framing. (Fig. 2)

Fig. 2. Flashing around southeast chimney could be causing leaks below.

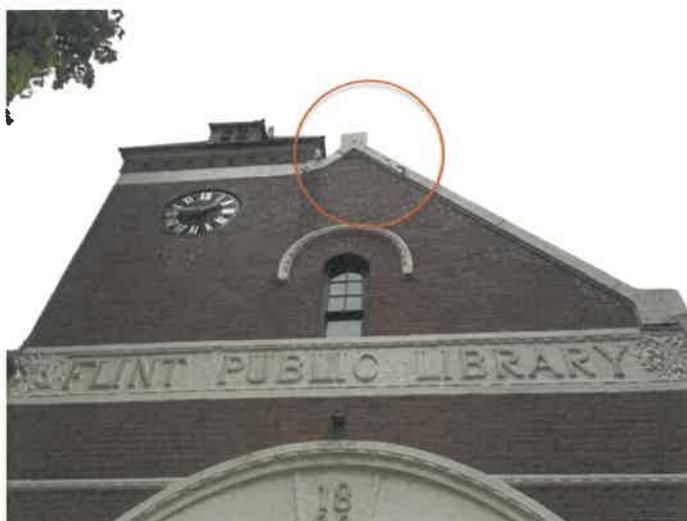
Nova Scotia Sandstone from the Wallace quarries was used for the beltcourses, arch over the main door, cornice, inscription panel and eave. The stone has been coated using a film forming material. It appears to be a non-breathable coating which is leading to it peeling from the stone in sheets. Moisture from the stone tries to evaporate through the exterior surface. When a non-breathable coating is applied, it creates a barrier to the moisture evaporation. The water and moisture build up below the surface of the coating and eventually causes the coating to bubble and peel. It is most evident at the gable stones and the beltcourses. (Figs. 3-4) The peeling will continue as the coating ages. It is not good practice to have a non-breathable coating on stone. It inhibits the natural movement of moisture through the stone and may cause the stone to deteriorate under the coating due to trapped water vapor in the stone pores. The trapped water can freeze in the winter and spall the surface of the stone. The coating is significantly lighter in color than the underlying sandstone, changing the appearance of the building quite dramatically.

Fig. 3. Paint coating peeling from sandstone trim at gable.

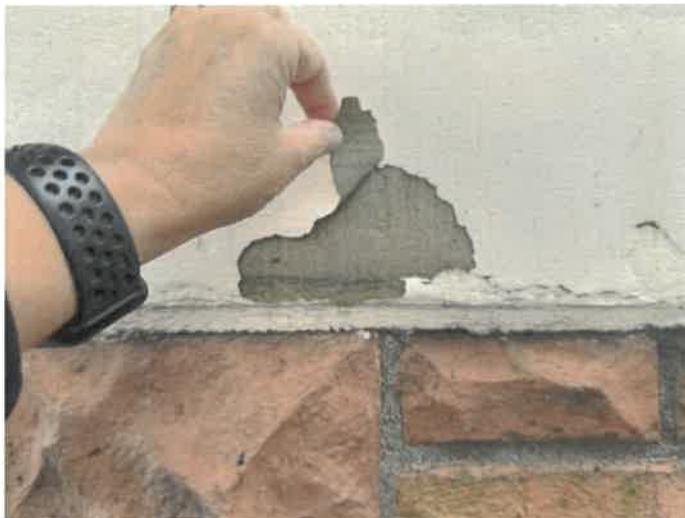
Fig. 4. Paint peeling from sandstone trim at beltcourse.

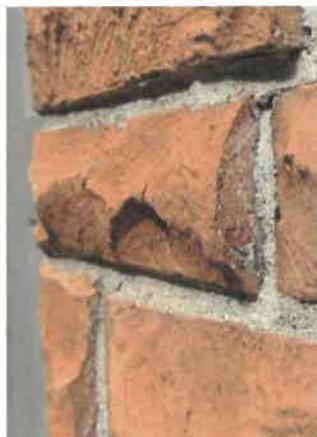
Fig. 5. Cut rusticated base showing clay or cement and aggregate matrix.

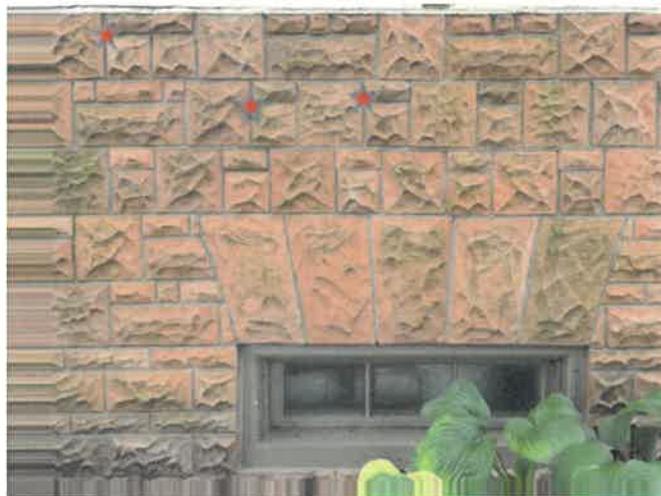
Fig. 6. Rusticated base showing duplicate cast patterns.

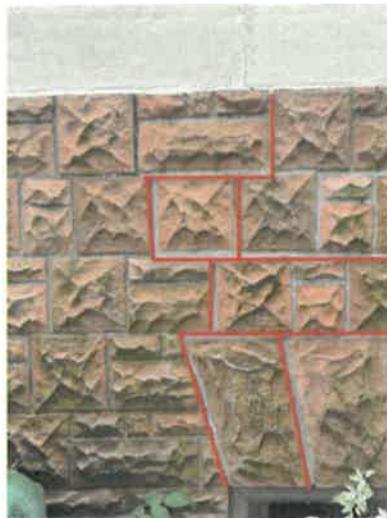
The base of the building, from the ground to the first floor window sill height, is red rusticated block. At a glance, it looks like stone. The National Register nomination form identifies the building base as "rusticated brownstone ashlar". The material is actually a manufactured product, not natural stone. It could either be fired clay terra cotta or pressed cement blocks. Both products were manufactured during the time period of the building's construction and would have been a less expensive material than cut stone. The material composition is visible at the basement entry where the blocks were cut around the new basement door opening. Sand and aggregate within a matrix are a clear indication that it is a man-made product. (Fig. 5) There are also duplicate patterns visible when one looks closely. (Fig. 6) The material is in excellent condition and is not experiencing any deterioration, other than some step cracks that are contained within the mortar joints. (Fig. 7) The blocks themselves are not eroding, spalling or deteriorating.

Fig. 7. Step crack through mortar joints. Red lines show locations of open or cracked joints.

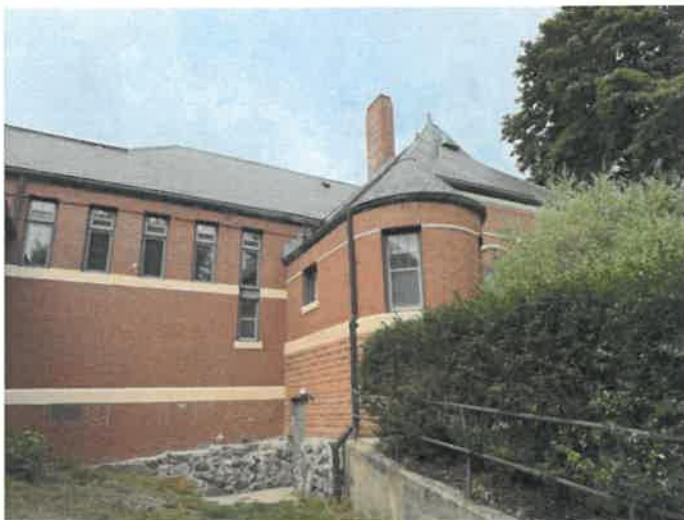
The granite rubble foundation was intended to be below grade and only exposed on the interior basement walls. The rubble foundation is now exposed on the east elevation where the grade was lowered in 2006 to introduce a basement door. The rubble wall was repointed and appears to be in good condition (Fig. 8).

Fig. 8. Exposed granite rubble foundation wall on east elevation.

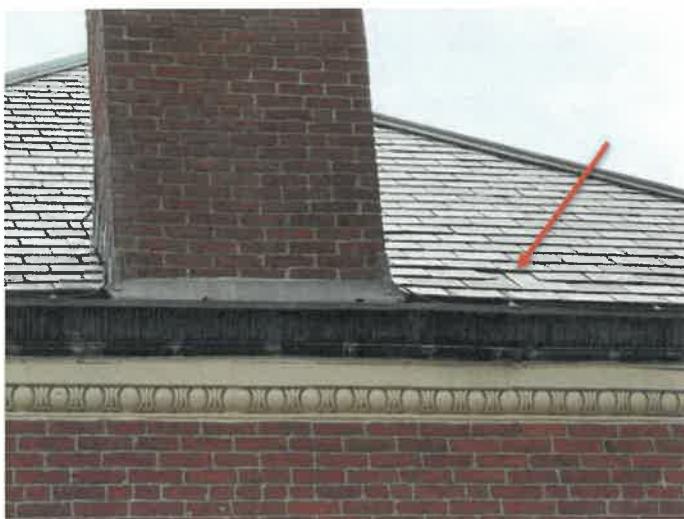
maintained properly it could have another 50 years of useful life. Aside from a few missing, loose and slipped slate, the roof is in good condition. (Fig. 9)

Fig. 9. Slate roof around west chimney showing loose and missing slate.

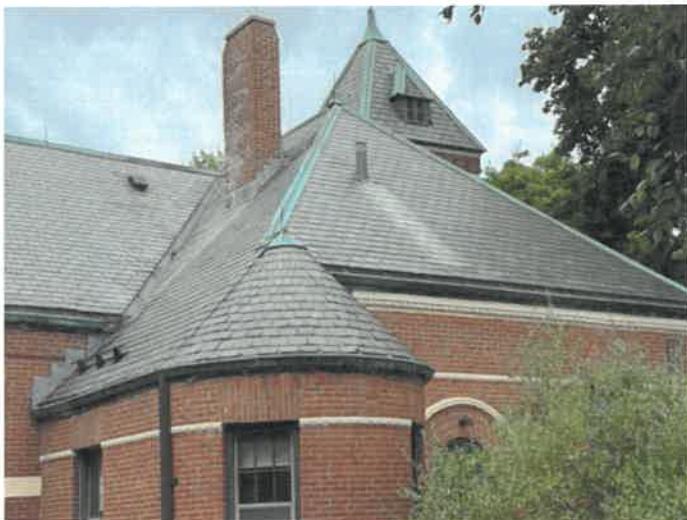
The copper flashings and gutters have a 30-50 year life span and typically require replacement before the slate roofing materials. Water runoff wears holes in the gutters and the flashing, which often directs water to the interior of the masonry walls or wood trim. These elements are in varying conditions around the building, from good to poor. Some have been replaced as they have worn out, others are nearing the end of their lifespan and require replacement in the near future. The copper hip flashing was called for replacement in 2006 documents, but it looks like it was not replaced. The step flashing around the north gable, tower and chimneys appears to be in very good condition, indicating that it may have been replaced in 2006. (Fig. 10) It is unclear what the age of the gutters and downspouts are, but they appear to be functioning properly and not exhibiting signs of wear.

Fig. 10. Copper gutters, downspouts, valleys and hips.

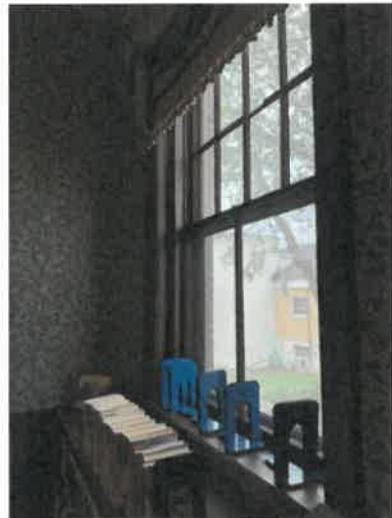
The original wood windows are intact and appear to be in good condition. (Fig. 11) There are stained glass windows in the two north openings. Aluminum storm windows were installed over the wood windows and the stained glass windows, possibly as part of the 2006 work. They help to protect the original wood and stained glass windows and appear to be functioning properly. The presence of the storm windows made review of the wood trim and exterior surface of the windows difficult. (Fig. 12) The wood windows appear to be in good condition, except as noted below. There was no obvious bowing or sagging of the lead observed at the stained glass windows. (Fig. 13)

Fig. 11. Original double hung wood window.

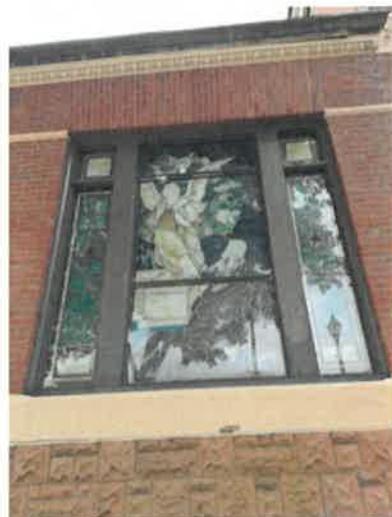
The attic wood window on the north elevation is in poor condition, with significant deterioration of the bottom rail. (Fig. 14) The wood trim around the stained glass window on the north elevation, first floor, is in poor condition with deterioration of the trim around the stained glass. (See Fig. 12)

Fig. 12. Wood window trim is in poor condition, especially at the base of the mullions. Note storm windows on exterior.

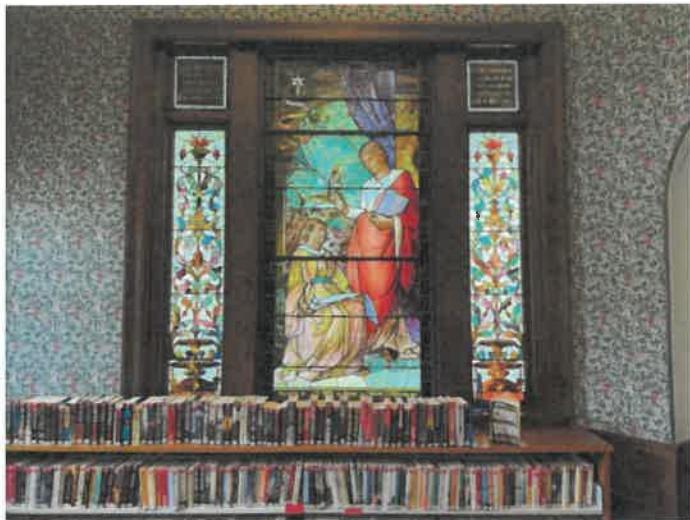
Fig. 13. Stained glass window in parlor.

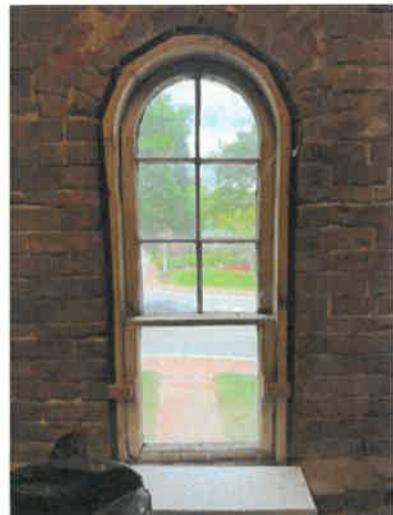
Fig. 14. Double hung wood window in attic in poor condition.

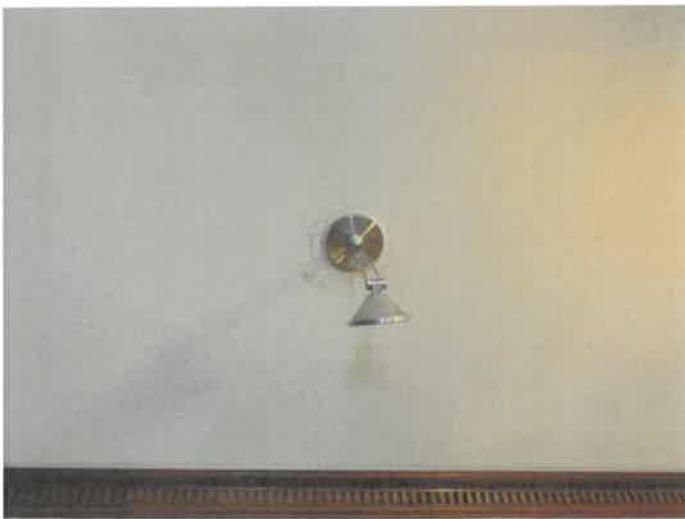
Fig. 17. Water staining around light fixtures in balcony.

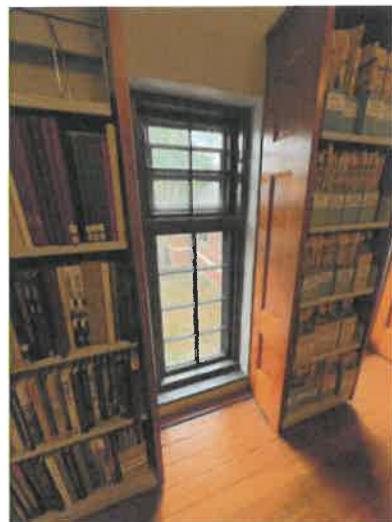
Fig. 18. Wide gap between floor boards along east and west walls in balcony.

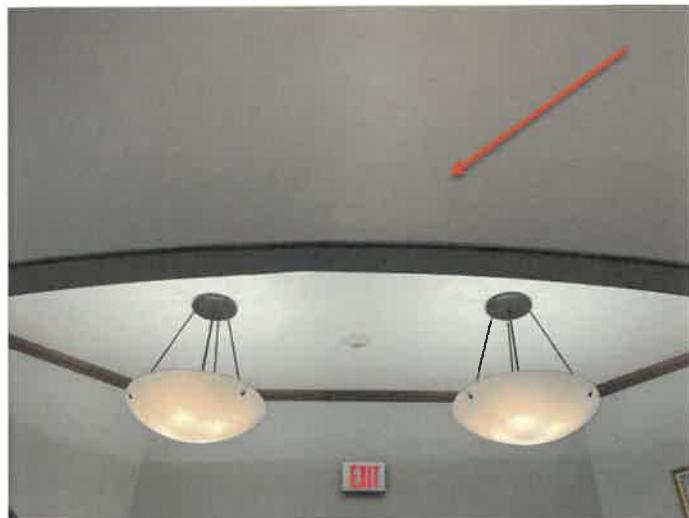
Fig. 19. Small crack in plaster over arch.

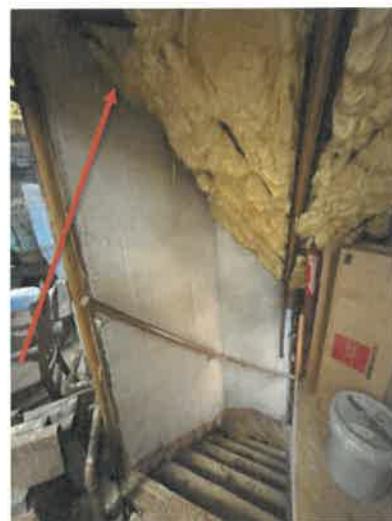
Fig. 20. Location of water infiltration.

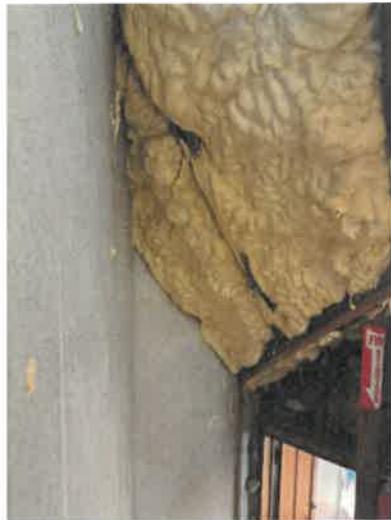
Fig. 21. Location of water infiltration at attic stairs.

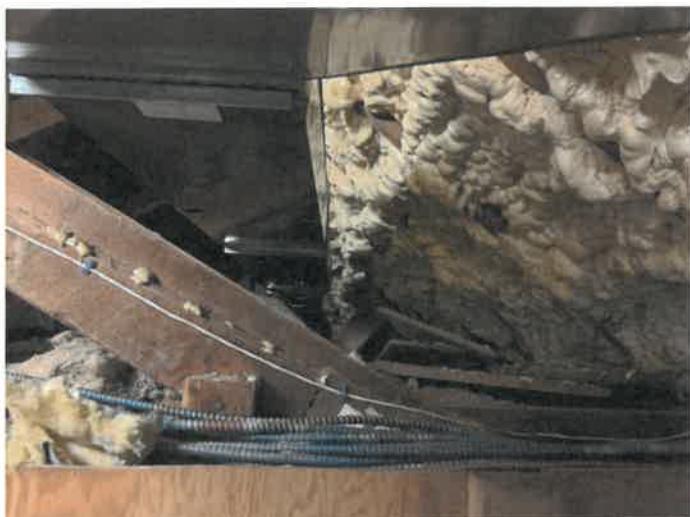
Fig. 23. Attic area above balcony light fixtures, inaccessible for leak investigation.

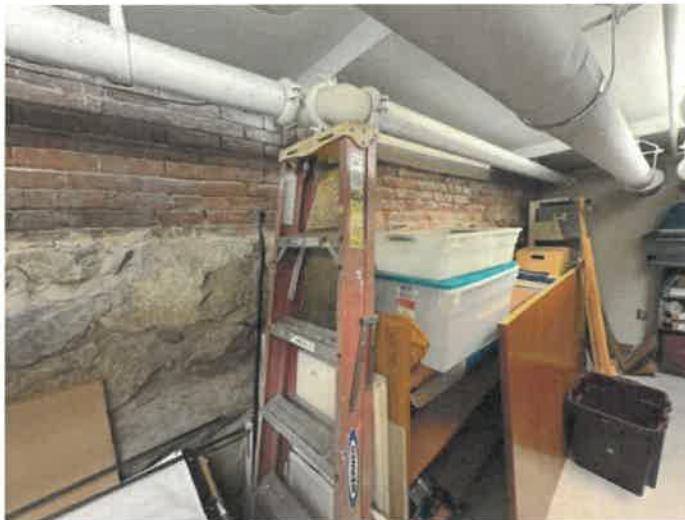
There are exposed brick and rubble stone walls in some areas of the basement. There are small areas of minor mortar deterioration, but the walls are mostly intact and do not require any immediate attention. (Fig. 24)

Fig. 24. Basement walls – brick and rubble stone.

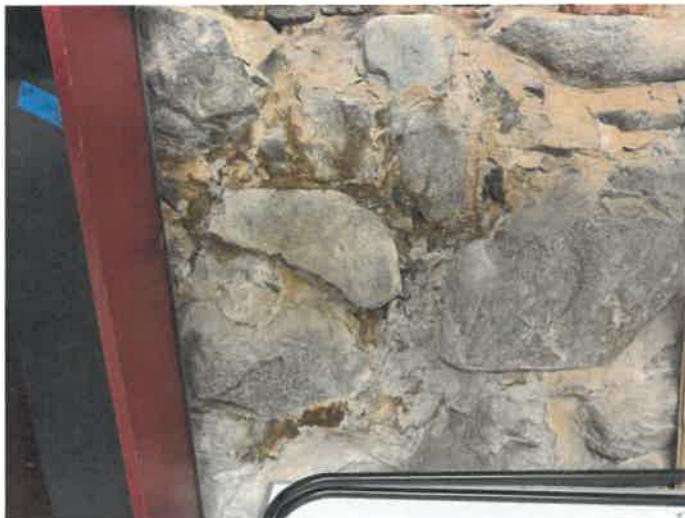
There are some dark mortar stains in the rubble stone walls that are likely caused by minerals leaching from the soil. This is a typical condition in below grade walls and is not a concern, unless increased water infiltration is observed at these locations in the future. (Fig. 25)

Fig. 25. Dark staining at mortar joints, possible mineral leaching from soil.

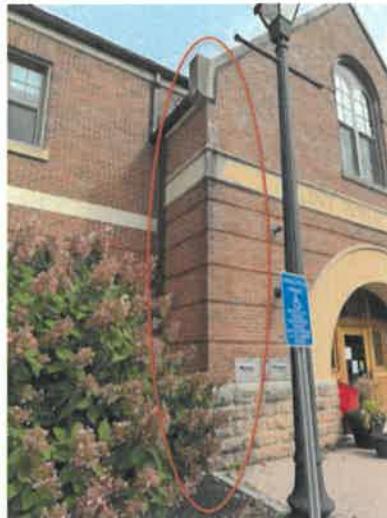
Fig. 26. Dark soiling from gable runoff.

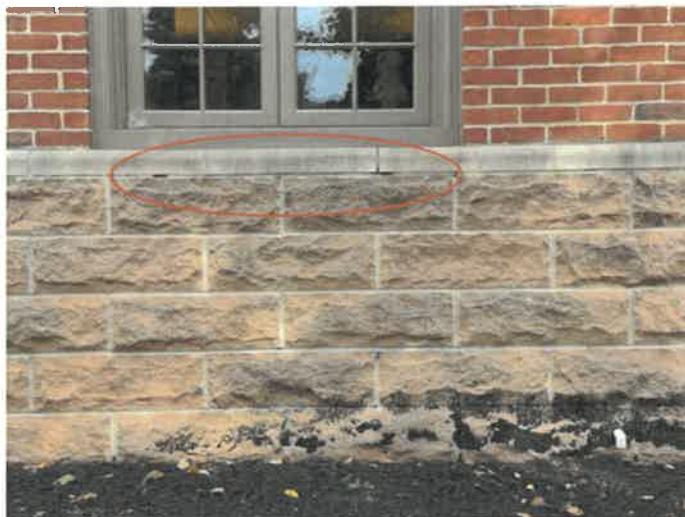
Fig. 28. Open mortar joints at the belt course and base.

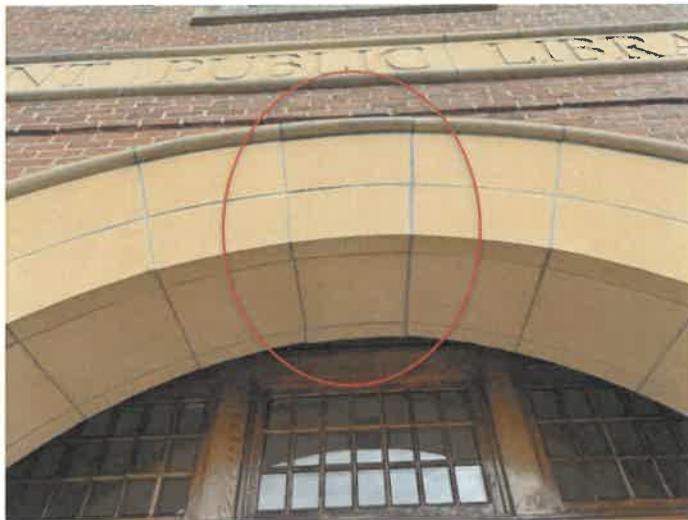
Fig. 29. Open mortar joints in arch.

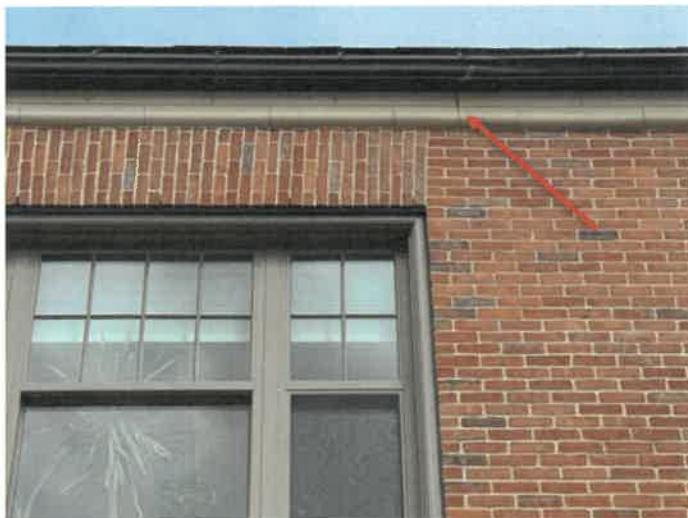
Fig. 30. Isolated cracks in cast stone.

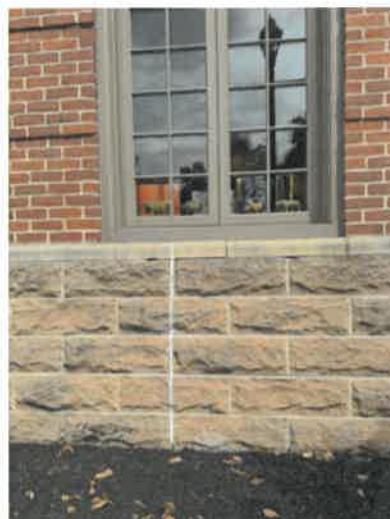
Fig. 31. Sealant material at expansion joints dried and shrinking.

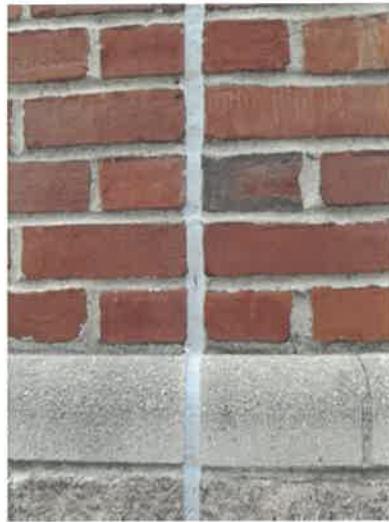
Fig. 32. Sealant material at expansion joints dried and shrinking.

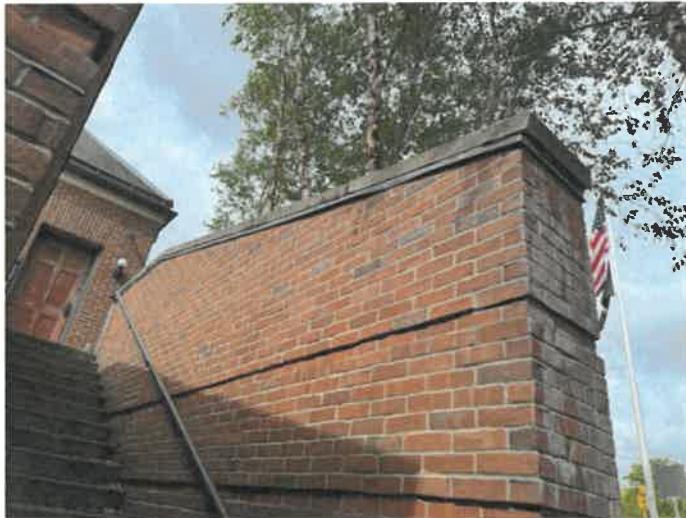
Fig. 33. Capstones at east stairs are shifting.

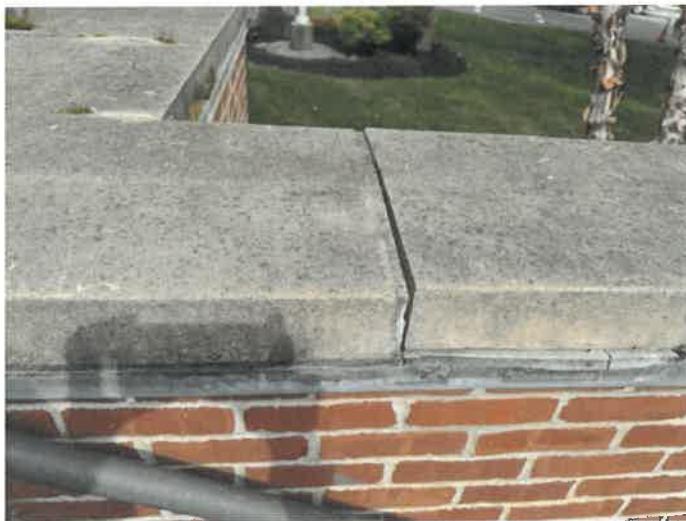
Fig. 34. Gaps at joints between shifting capstones.

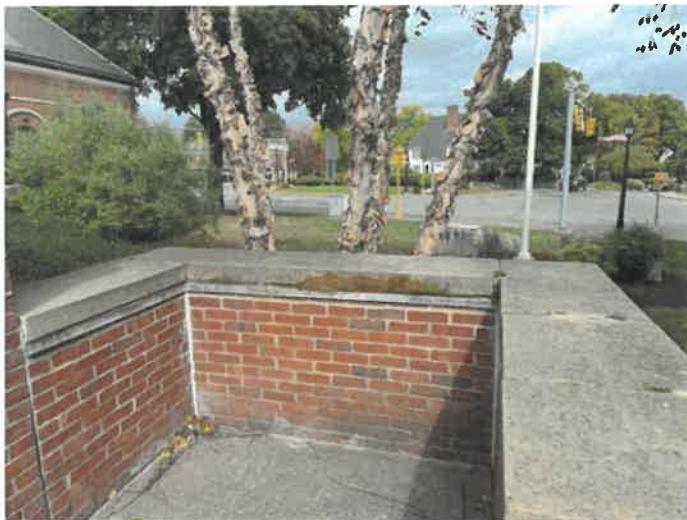
Fig. 35. Biological growth at stair capstone joints.

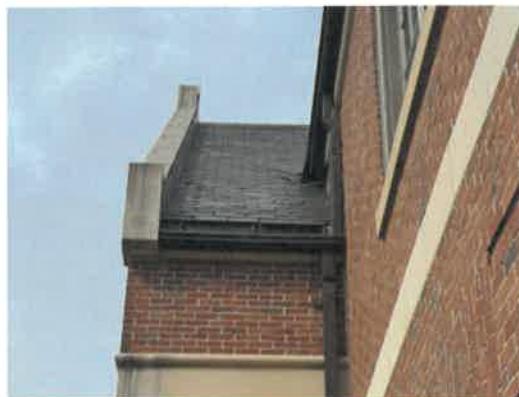
Fig. 36. Missing and loose slate.

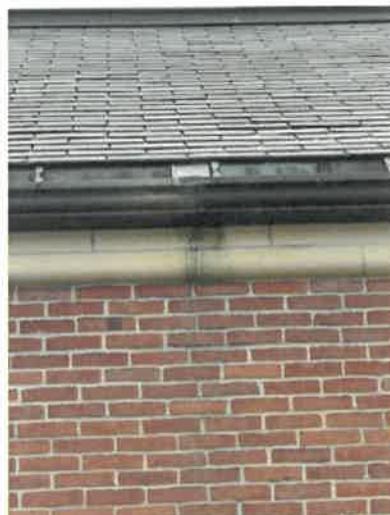
Fig. 37. Open seam on copper gutter causing copper staining below.

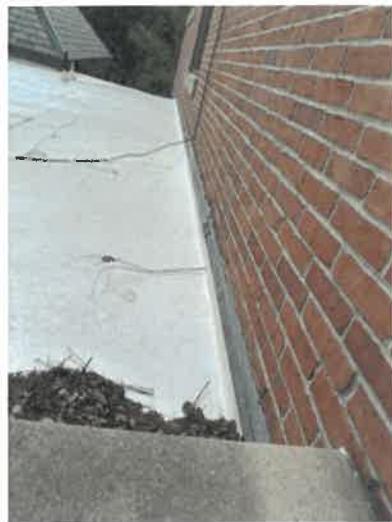
Fig. 38. Defective flashing above water leaks in Children's Library ceiling tile.

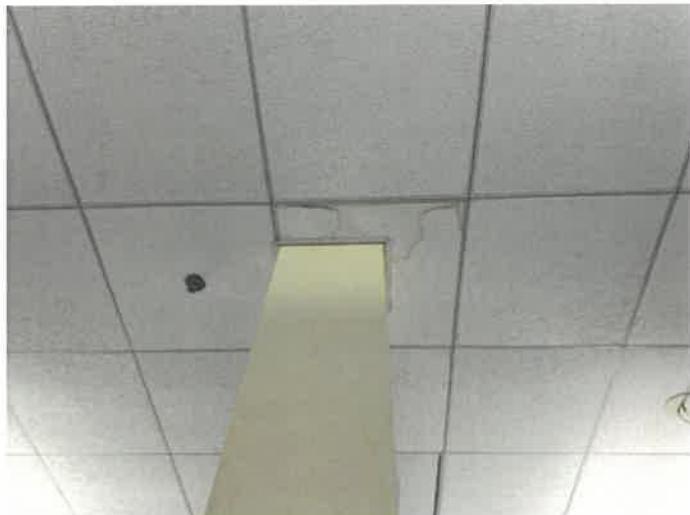
Water leaks have stained the drop ceiling in the children's library, directly below the exterior wall and flat roof flashing above. (Fig. 39)

Fig. 39. Water leaks below defective flashing at flat roof above.
