Flint Public Library

Conditions Assessment

Building Conservation Associates, Inc. (BCA) was hired by the Town of Middleton to conduct a conditions assessment of the Flint Public Library. Two site visits were conducted in August and September 2024 to tour the buildings, take photographs and note the materials and conditions. Loretta Swift Johnson, Flint Public Library Director and Justin Sultzback, Middleton Town Administrator met with Lisa Howe on site in August. Documents related to the 2006 addition were reviewed, and Loretta gave a tour of the leaks, cracks and concerns observed around the building. BCA conducted a follow up visit in September to complete a more in depth review of the conditions.

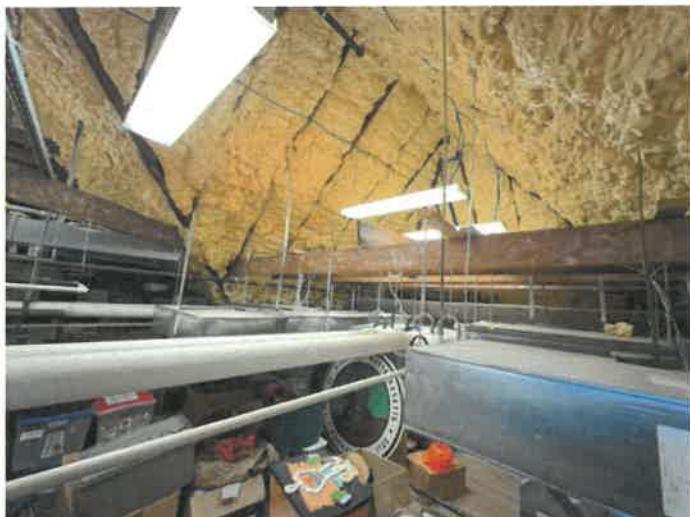
Fig. 22. Spray foam insulation installed at underside of roof.

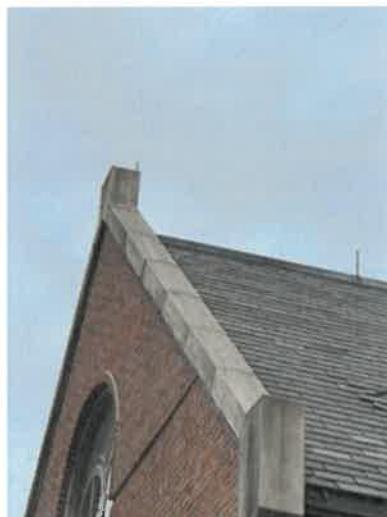
Cast stone was used for the rusticated base, beltcourses and gable stones. A large arch with an inscription panel above creates the south entrance. This entrance is accessible and off of the parking lot. The color of the cast stone is more yellow than the sandstone on the original building. Either the cast stone was colored to replicate the coated sandstone, or the sandstone was coated to match the cast stone on the addition. Through wall flashing was installed under the gable stones to provide an additional layer of protection to the underlying brick walls. (Fig. 27) While the installation of through wall flashing protects the brick wall from water saturation through the cap, the gable cap stones are flat on the top. In heavy rains, water runs down the gable slope and down the face of the brick surrounding the entrance.

Fig. 27. Cast stone gable with through wall flashing between cast stone and brick.
